## ENERGY AUDIT IN IRT OF MOISTURE AND DAMPNES DETECTION AND DIAGNOSIS IN BUILDINGS

A selected preliminary survey of various spots in a six-story university building in Rio de Janeiro built in 1960s was carried out with the intent of capturing real and thermographic images of moisture and dampness detection and defect for a qualitative analysis of various types of moisture identifications in the building. The walk-through passive IRT method, already identified as a viable method in energy audit, was used to identify the various features of moisture presence and classified into subdivisions for a qualitative analysis. The climatic conditions were stable producing clearer infrared images. In terms of good practice, outside inspections are best conducted during the night or in the early morning with heating systems switched on to maximise the thermal contrast [17]. On the contrary, inside inspections are best collected during daytime or early evening periods to reduce the effects of the solar heat loads [17], this timing was observed for this survey.

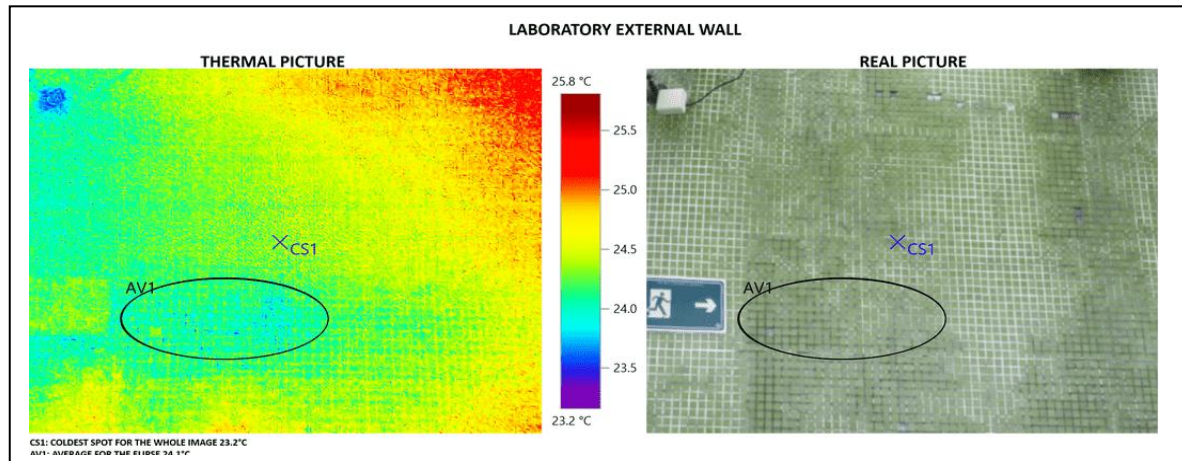
The images revealed the existence of two different forms of moisture. The first one, represented in Figure 1, is moisture from rainwater-induced percolation (PM). Figure 1 depicts one of the external walls of the university's laboratory. Despite the fact that the IRT image was captured while the sun was still shining, the thermogram clearly shows a significant amount of moisture. The thermogram's Xcs1 point represents the coldest location, and the wall's average temperature is shown by AV1. A PM GUT aggregate score of 125 is obtained from the qualitative assessment for the presence of moisture (see Table 1, column 4). By multiplying the assigned qualitative scores for gravity ( $G = 5$ ), urgency ( $U = 5$ ), and tendency ( $T = 5$ ), the 125 score was calculated. This suggests that the wall is seriously moist and that there is significant percolation-related movement in the wall. The wall depicted in Figure 1 is situated at the highest point of the six-story building, directly facing the impact of the sun and driving rain.

**Figure 1:** Thermography and real picture of a university building laboratory external wall showing high moisture presence and pattern

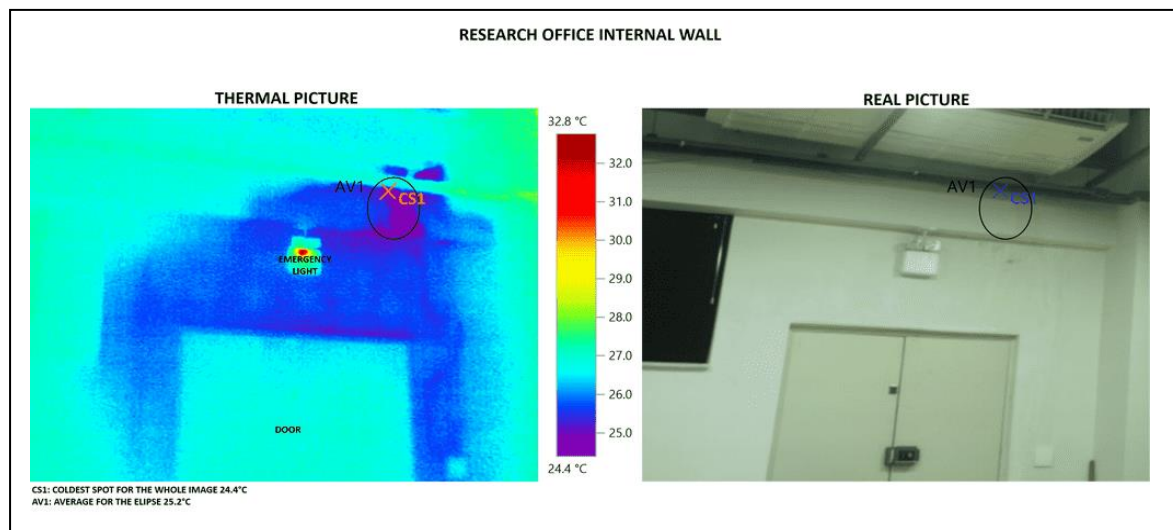
The second set of images in Figure 2 was taken inside a research office. The water outlet line from the air conditioner (AC) was leaking, which is why there was moisture on and in the wall. As was discovered during this walk-through internal survey examination, this

amply illustrates the ability of passive IRT to more clearly identify both surface and internal moisture present in walls under controlled climatic conditions. Take note of the location of the AC pipe leak, which is indicated inside the ellipse in both the thermogram and the actual photo. This area is the moistest (and coldest) of the entire surface area that was photographed. Meanwhile, one issue that can be found when analysing the functional differences of the HVAC system and visualising its performance during the design and installation phases is the detection of water leaks from pipes [3]. When the assigned qualitative scores for gravity ( $G = 5$ ), urgency ( $U = 5$ ), and tendency ( $T = 5$ ) are multiplied, a qualitative assessment of the AM GUT moisture presence score of 125 is obtained. This indicates a very serious moisture presence, but this time it is due to accidental moisture (AM), as defined in the methodology section.

**Figure 2:** A university building research office internal wall revealing serious moisture presence and movement more visible and elaborate in the thermogram
